SERVICE INFORMATION

rev. 07/2010

Fitting instructions for the Concentric Slave Cylinder (CSC)

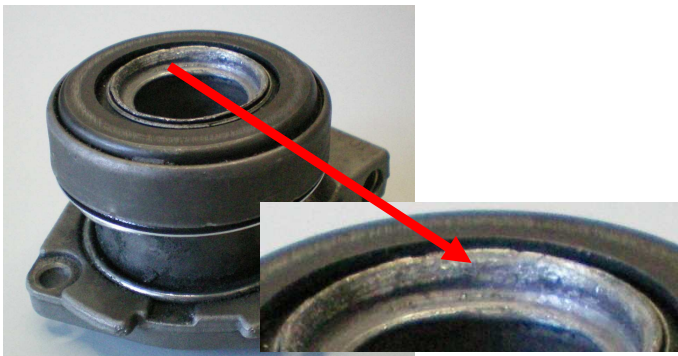
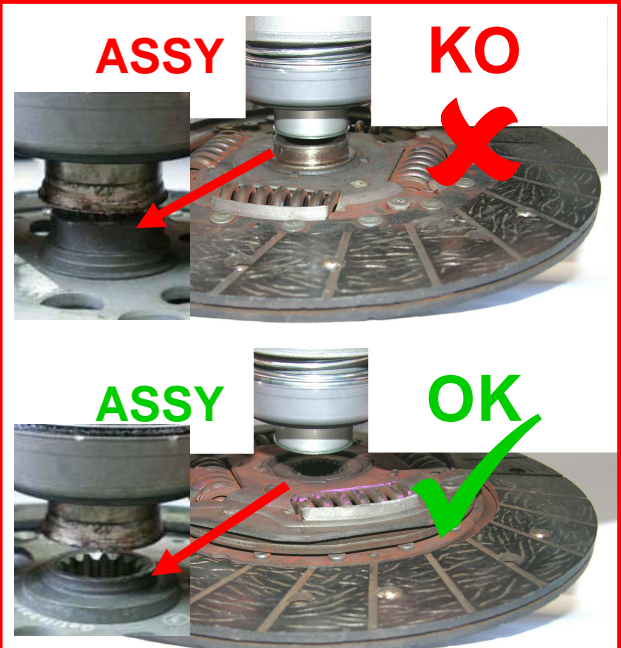
1 - ASSEMBLY ERROR FLYWHEEL OPPOSITE SIDE

Flywheel assembled in wrong way (opposite side) will damage the CSC causing deformation of the retaining ring and leaking.

Retaining ring damage

- Always read the specifications of the vehicle manufacturer
- Prior disassembly mark the external side of the flywheel with a colored dot to remind the correct assembly side
- Original spare parts flywheel is marked on the correct assembly side

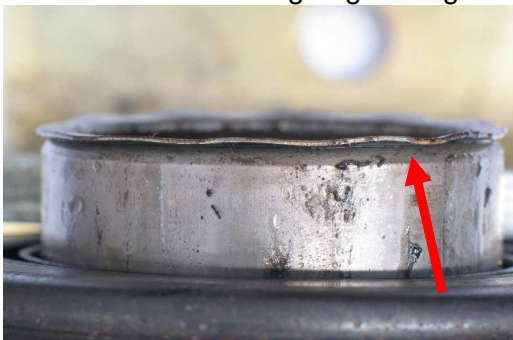
In case of error in assembly or bleeding the CSC system could work in over stroke. An exceed of stroke will result in the damaging of the retaining ring or in the damaging of the primary seal as the sliding sleeve can slip out of the guidance and the sealing ring can shear off when it is pressed in the guidance again.

Over-stroke retaining ring damage

- Always read the specifications of the vehicle manufacturer
- Do not depress the pedal several times in succession when bleeding; depress just once
- Assemble the clutch system with the correct mechanical clutch tools for “counter force free”
- NEVER bleed the CSC alone – bleed only when flywheel and clutch are assembled

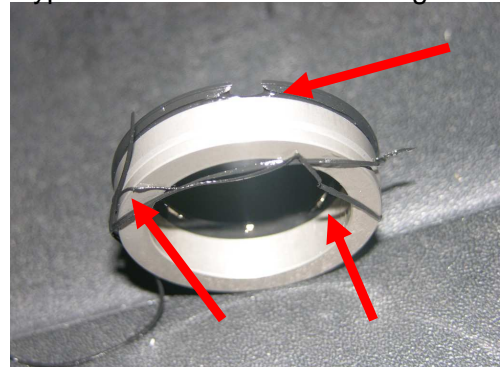
Typical Over-stroke seal damages

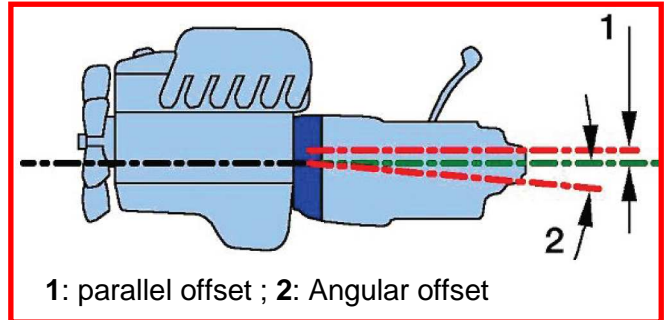
3 - AXIAL AND ANGULAR SHAFT/ENGINE MISALIGNMENT

Excessive axial or angular (or both) CSC assembly error (reference to gear shaft) lead to a reduced functional and service life of CSC **reducing the life of the shaft seal (gearbox input shaft seal).**

The root cause for excessive axial or angular (or both) CSC assembly error is to be found in alignment errors between engine and shaft.

- Centering between engine and gear box is not correct (deformation, heavy dirt or wear);
- Other parts (e.g. grounding straps) trapped between engine and gear box during installation);
- Flange bolts loose or not properly tightened;
- Close-tolerance sleeves or pins missing / damaged;
- Gearbox input shaft with no guidance as pilot bearing in the flywheel is absent or badly worn;
- Clutch bell housing warped because attaching bolts have not been evenly tightened or deformed due to the effect of force such as dropping or striking hard when fitting;

In case of excessive axial and angular misalignment and shaft seal wear, shaft rotation can generate mineral oil mist that could go in contact with internal **CSC primary seal with high volume change** leading to leakage and low service life.

- Always read the specifications of the vehicle manufacturer
- Assembly the clutch system with the correct mechanical clutch tools for “counter force free”
- Always check the finish of the surface of the shaft in seal working area prior to assemble CSC

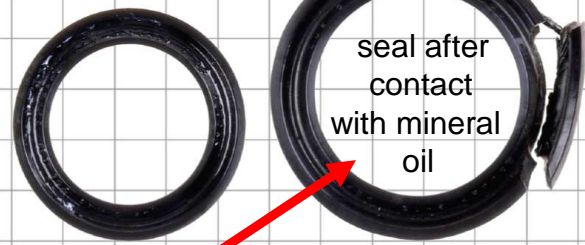
If the wrong hydraulic fluid is used, the seals in the system will be damaged. In systems which are combined with the brake system, faults may arise in the brake system.

Volume change - contact with mineral fluid

STD dimension

- Always read the specifications of the vehicle manufacturer
- Always use DOT3 / 4 fluid – DO NOT USE MINERAL OIL
- Dispose of the waste oil according to proper country and/or state disposal regulations.
- Always avoid use of grease or other lubricants / cleaning agents in contact with CSC

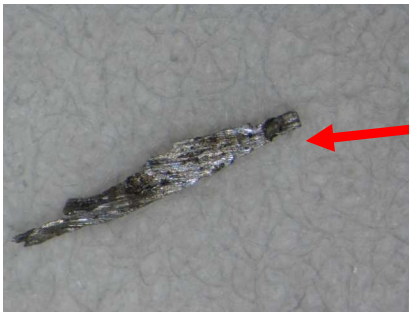
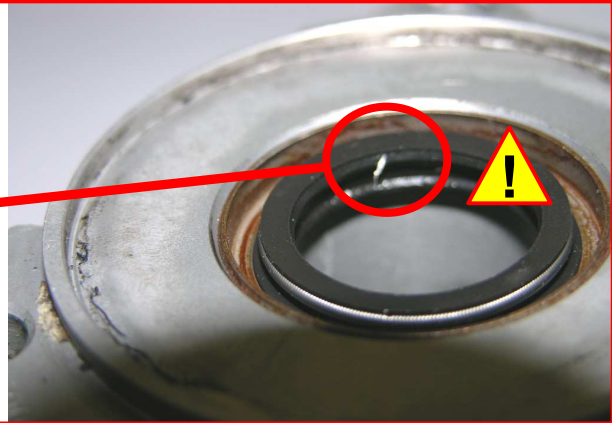
7 - CONTAMINATION – GEAR SHAFT

Contamination on shaft coming from disassembly or re-assembly operation may cause leaks when dirt articles accumulate under the sealing lip of the gear side shaft seal or on the bell-house sealing o-ring. and may also cause permanent leaks when the lip seal swells.

Aluminum swarf causing leakage from gear side

- Clean old gaskets or remove it (if supplied with CSC)
- Clean the transmission input shaft and verify not excessive wear on shaft seal swept area
- Do not use any lubricants or cleaning agents as they may damage the gaskets / oring
- Maintain attention to the level of cleanliness and verify visually that no contamination is present on shaft seal and oring
