HARD OR EXCESSIVE PEDAL PRESSURE DIAGNOSIS

Wingate would like to welcome you to this video entitled “Hard or Excessive Pedal Pressure Diagnosis”.

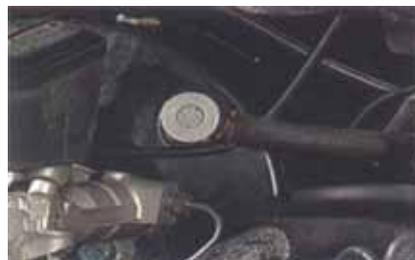
With the engine running remove the check valve from the booster, or in the case of vehicles with in-line check valves, the hose from the booster.

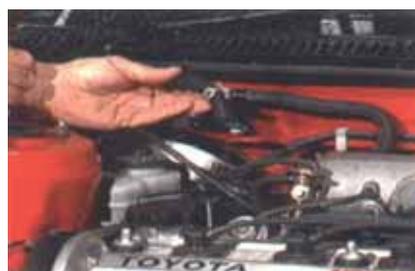
In each case a sharp rush of in-going air should be heard. On a petrol engine vehicle this should be accompanied with rough running, or stalling of the engine.

If this does not happen, switch the engine off and remove the check valve.

You should be able to draw air through it from the manifold side, but not blow through it.

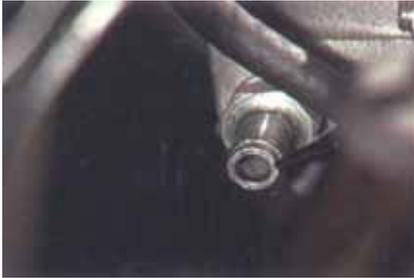
Pulling the vacuum hose off when the engine is idling should be accompanied by the sound of a large amount of air being drawn in and on a petrol engine, rough running or stalling.

If this does not occur the fitting will have to be removed and unblocked.

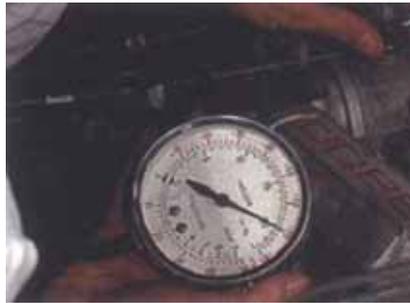
This can be done by attaching a vacuum gauge to the fitting and comparing the readings against manufacturers specifications.

In the absence of these a good engine in a normal state of tune should produce at least

minus 55 KPA when held steadily at approximately 1800 RPM.

Low manifold vacuum could be an indication of internal problems in the engine, inlet manifold leaks, or an engine which has been highly modified with a non-standard camshaft.

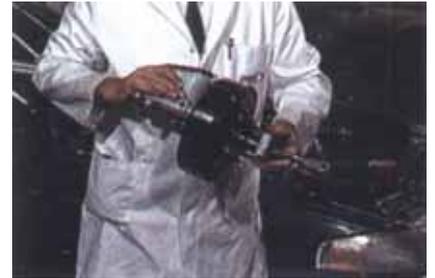
the final check in the path which is the master cylinder and booster size.

A common practice amongst some service personnel when faced with low pedal problems is to fit a master cylinder of a larger diameter than was originally fitted to the vehicle.

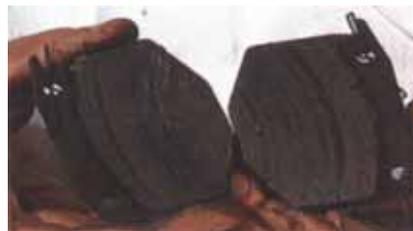
Burning is easily recognised as the linings will appear black and usually have deep cracks over the surface of the material.

Some discolouration of the drum or disc can also be expected to accompany this condition.

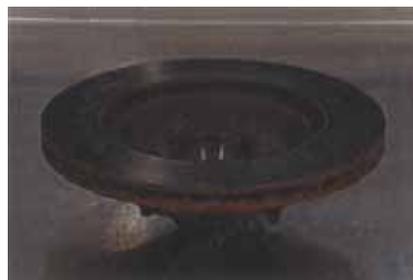
Leaking hydraulic cylinders or axle seals can also change the linings effectiveness by

covering them with grease, oil or hydraulic fluid.

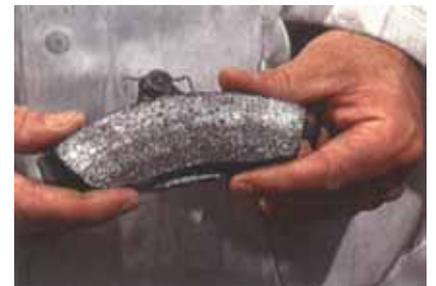
If the problem has only occurred since the brakes were re-lined the cause may be that the pads were not bedded in properly, or not bedded in at all.

You may need to question the customer as to how they drove the vehicle immediately after the brakes were re-lined to help establish if this was the problem.

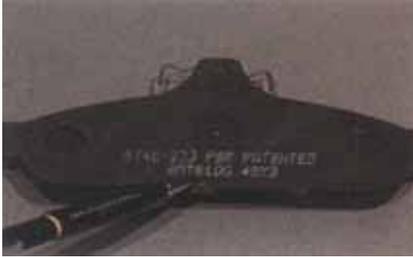
Finally, the type of lining material itself should be checked to see if it is suitable for the vehicle.

There is a wide variety of materials available on the market today and not all are suitable for every vehicle.

Pads which cannot be identified from the markings on their backs as being suitable for the vehicle should be discarded and replaced with those originally specified by the manufacturer.

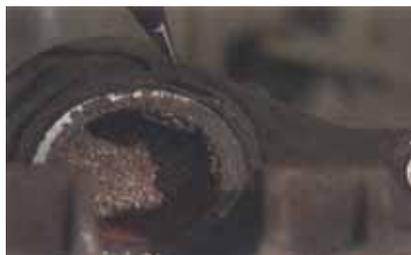
Often an indication that a piston has seized, particularly with disc brake caliper pistons, is that the dust boot has torn, allowing moisture and dirt to enter and form corrosion around the piston.

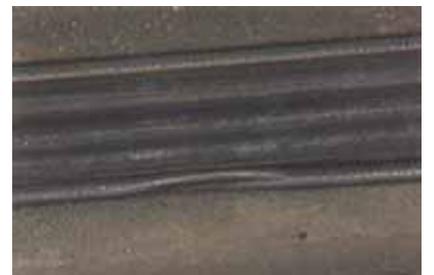
Flexible hoses can become damaged and twisted when calipers are replaced after being overhauled or having pads replaced.

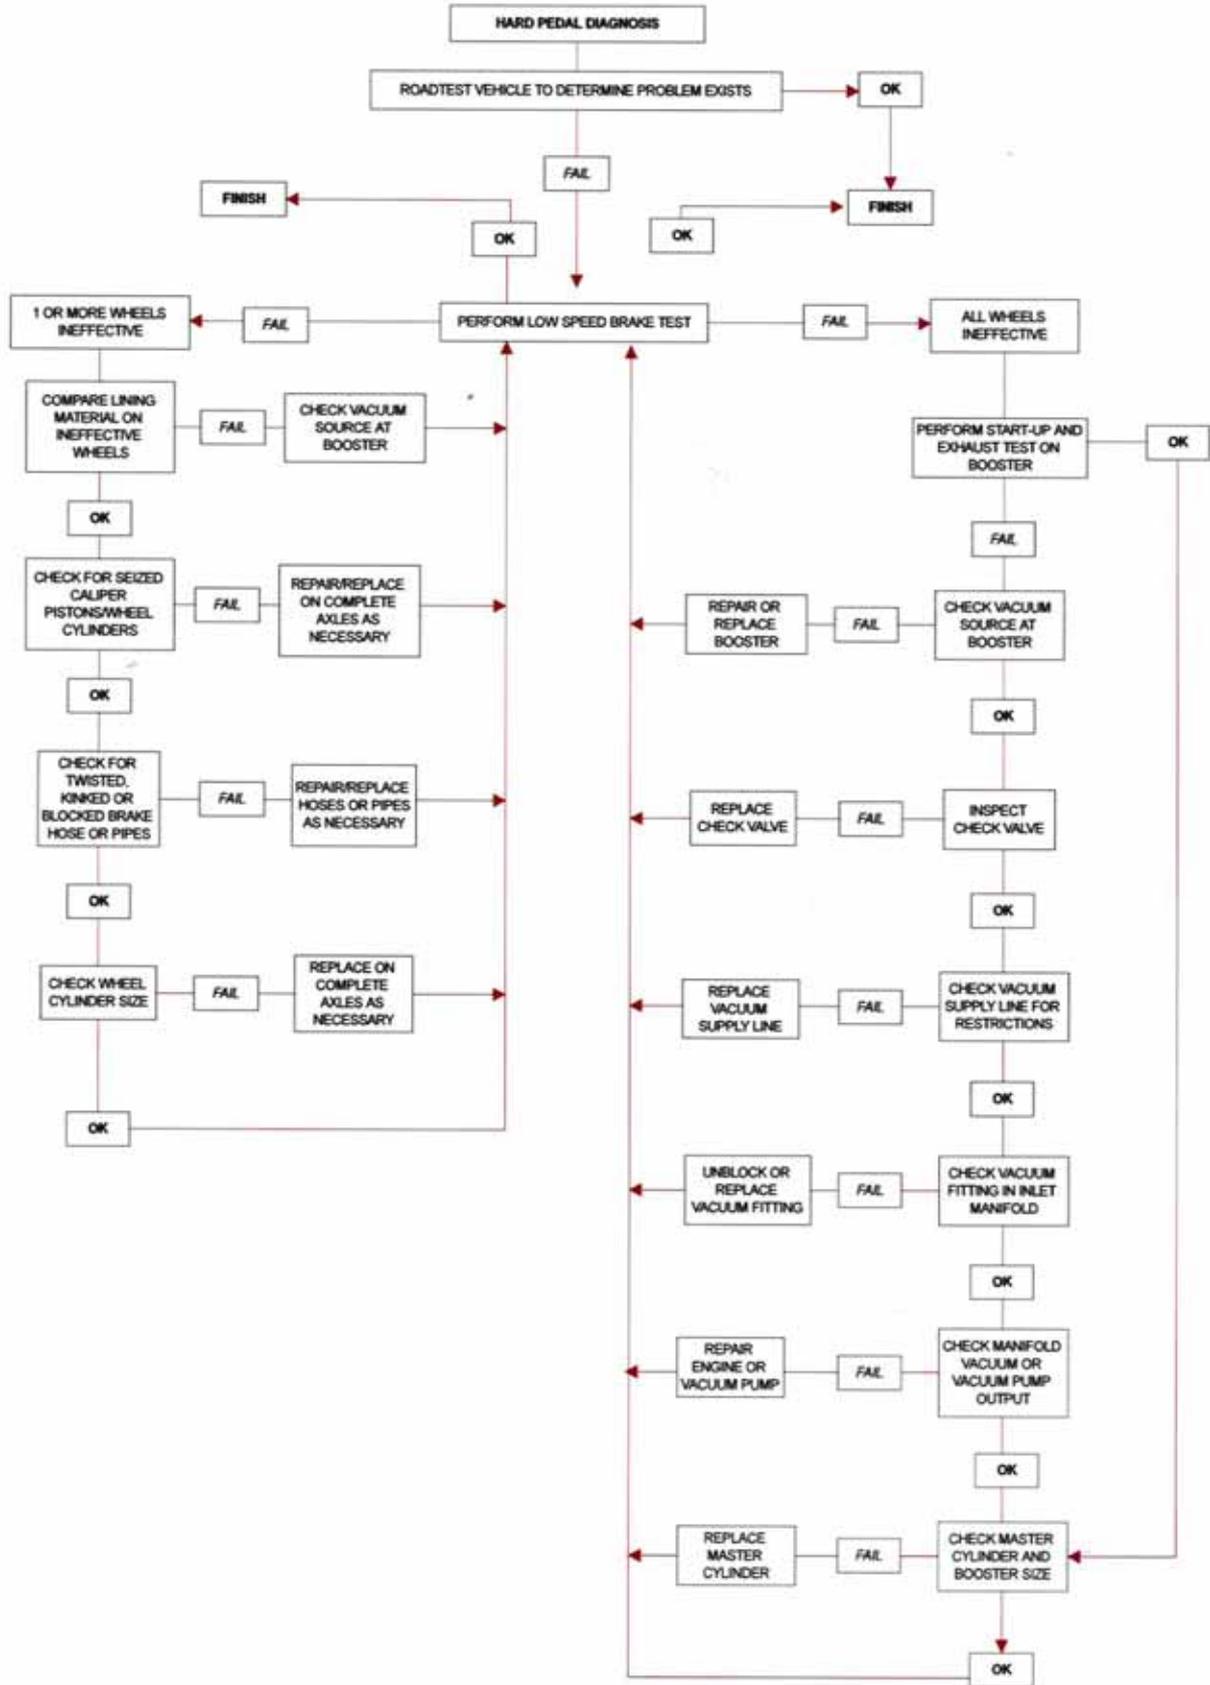
Throughout the course of the video, reference to the flow chart will be made. The chart provides a logical procedure which the technician can employ to diagnose these types of problems.

If we now refer to our flow chart we can see that one of two possible results should have been obtained.

The first is that no markings from the wheels was evident, or at best they were extremely faint. This would indicate a problem that would affect all the wheel brakes, such as a booster or master cylinder problem.

The second is that the wheel markings on one or more axles were uneven, suggesting a

problem in one or more of the wheel brakes.
